EGOLF RECOMMENDATION 014-2019

Subject of Agreement (max. 65 characters)	Protection of the SBI trolley
Related test standard	EN 13823
Date of issue	2019-01-02
Reference original query	Helpdesk TC1 2017-07
Previous publication number (if applicable)	TC1 N667rev1
Keywords (max. 20)	molten, plastic, cleaning, CaSi, calcium silicate, mounting rail

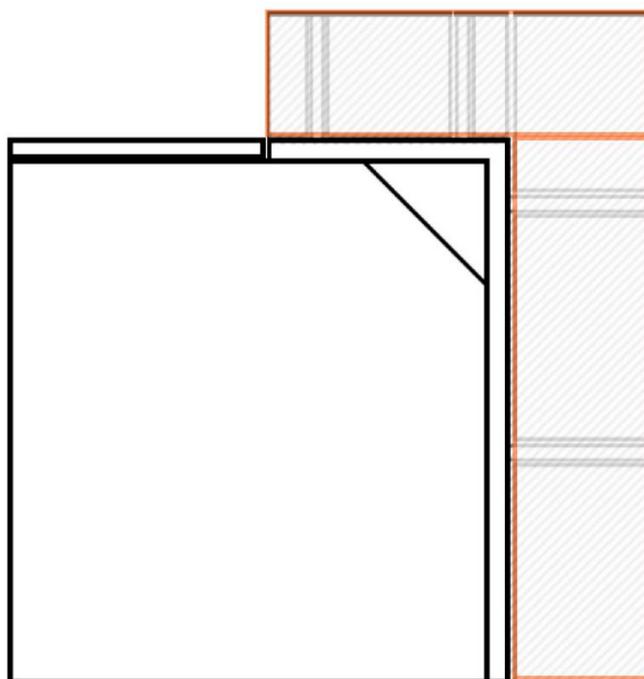
EGOLF agrees that, to reduce the risk of residual test material in the trolley, the steel mounting rails on the bottom can be removed, together with the top layer of CaSi. The bottom of the trolley shall then be covered with an uninterrupted (save for one joint as depicted in the figure) CaSi-plate with the same thickness (20 mm) as the removed parts, or with two CaSi-plates with the same thickness as the removed parts. If required e.g. steel angles as usually used for clamping the test specimen can be screwed onto the calcium silicate sheets on the bottom of the trolley in order to keep the test specimen in place.

When testing products that contain meltable thermoplast in the SBI apparatus, the molten material flows into the joints in the trolley floor and through the steel mounting rails below the sample through which it can flow away from the test site. This represents an efflux of inflammable material and also – as the molten material is usually already quite hot – of energy away from the test site. It should therefore be prevented as it would yield an illegitimate advantage to such materials. Also, the trolley usually gets polluted by these molten plastics. Not only is cleaning the SBI trolley tedious, sometimes it is very difficult if not impossible to remove all remains of a test from the trolley. This is especially the case in the area behind the steel U-profiles, where the CaSi plates on the bottom of the trolley have been interrupted by the steel mounting rails.
