Public Project Report

EGOLF Round Robin

concerning the
Determination of a Building Product's Propensity
to Undergo Continuous Smouldering

acc. to **EN 16733:2016**

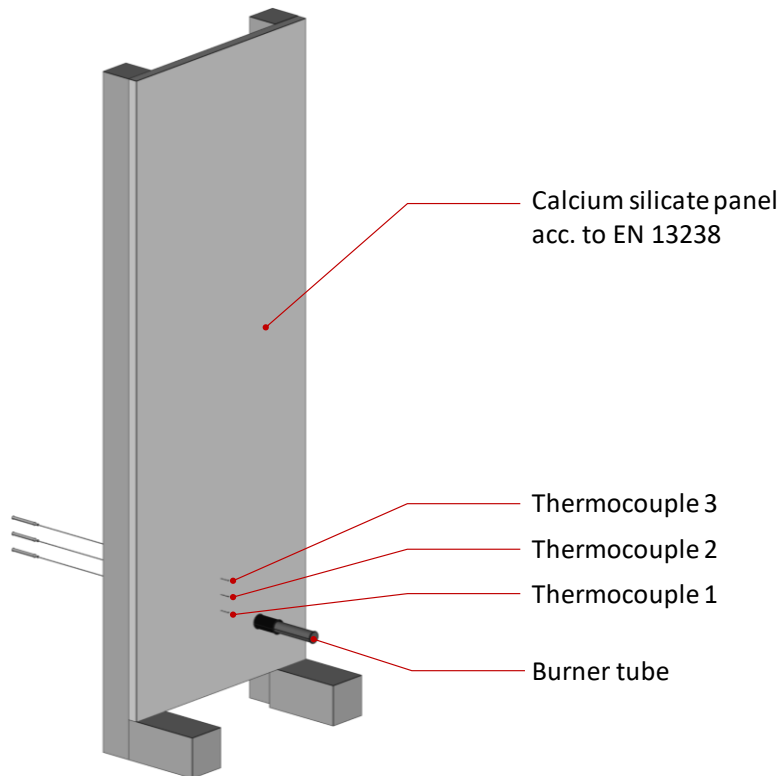
Figure 1: Overview of setup for the heat output test.

Afterwards, they conducted a series of measurements of the heat output of the burner. For this cause, a calcium silicate panel compliant with EN 13238 was used as a sample in which thermocouples were inserted at defined positions. Completion of this stage was mandatory for each laboratory before continuing with the material tests in the second stage. Figure 1 shows the setup for this test.

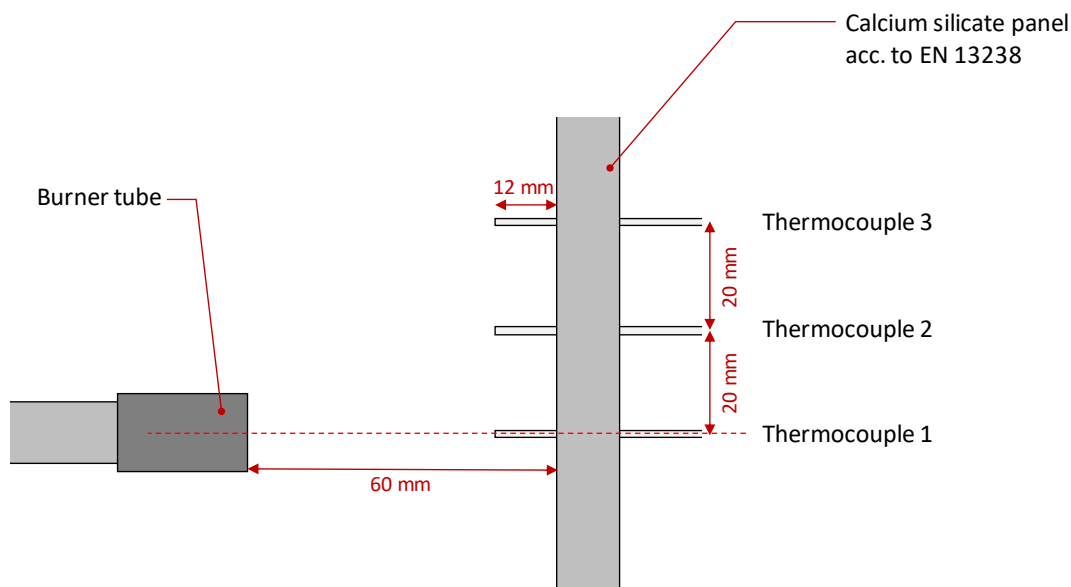
A calcium silicate panel in accordance with EN 13238 and a thickness of 12 mm was to be cut to 800 × 300 mm². The drill holes in the vertical middle axis of the sample were to be introduced in the sample as shown in Figure 2. They should have a diameter of 1.5 mm up to 2 mm and a vertical distance of 20 mm. The lowermost drill hole was to be in the axis of the burner.

Into these drill holes, three sheathed thermocouples of type K with an outer diameter of 1.5 mm were to be inserted. This is the same type of thermocouples as described for the tests in EN 16733. The enumeration of the thermocouples started at the lowermost one.

The thermocouples should perpendicularly protrude (12 ± 0.5) mm from the panel surface that was impinged by flame (see Figure 2). This way, cooling effects from the panel were deemed to be negligible.

Figure 2: Schematic drawing of the comparison test for the heat output.

Each laboratory measured the temperature of the burner exhaust gases at specific points in front of a calcium silicate panel (refer to Figure 2).

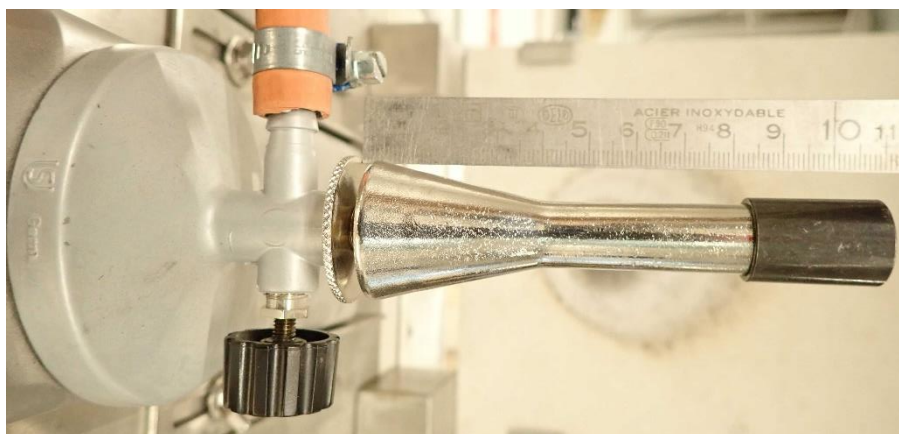
Figure 3: Teclu burner as used by nearly all of the participating laboratories. The actual total length of about 100 mm can be discerned.

However, as the scheme in Figure 7 of EN 16733 is to scale, one can already assume that the total length of the burner tube is actually supposed to be 100 mm instead of 135 mm. This corresponds with the measured burner tube lengths of all participating laboratories (see Figure 3). This is not surprising as nearly all Teclu burners used originate from the same manufacturer.

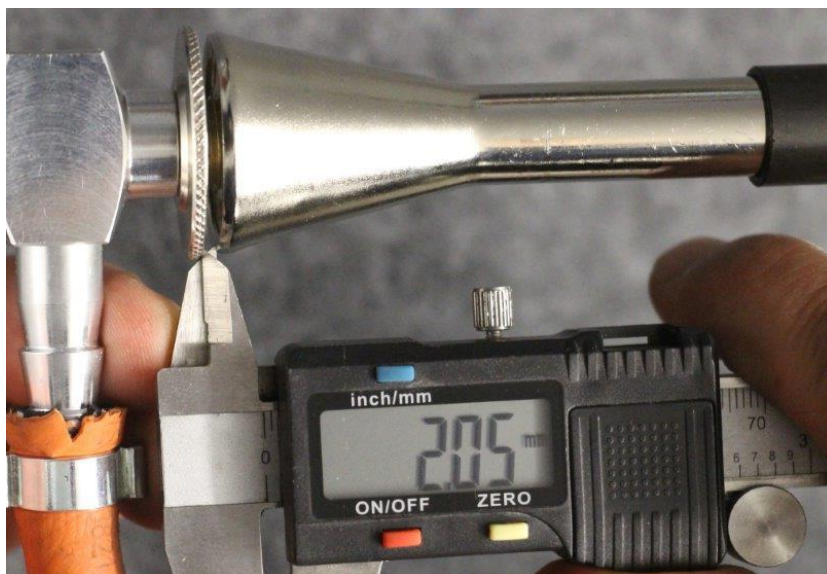
Figure 4: Air supply opening at the bottom of the burner.

This statement remains very vague. During this round robin, the actual possible opening of the air supply was measured by the laboratories (see Figure 4).

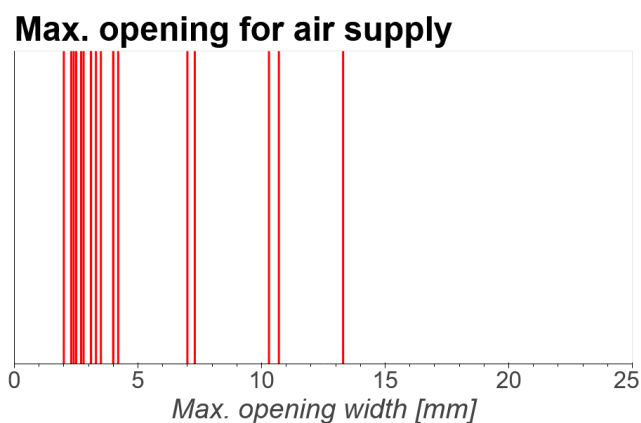
Figure 5: Distribution of measured maximum air supply openings in the laboratories.

An opening too small might restrict the air influx and hinder the complete combustion of propane gas. The measured results cover a wide range of possible maximum openings which greatly depend on the exact subtype of the employed burner and the way it is assembled in the test rig. Figure 5 shows the distribution of the maximum air supply openings found in the participating laboratories. This topic is further explored in paragraph 6.6.

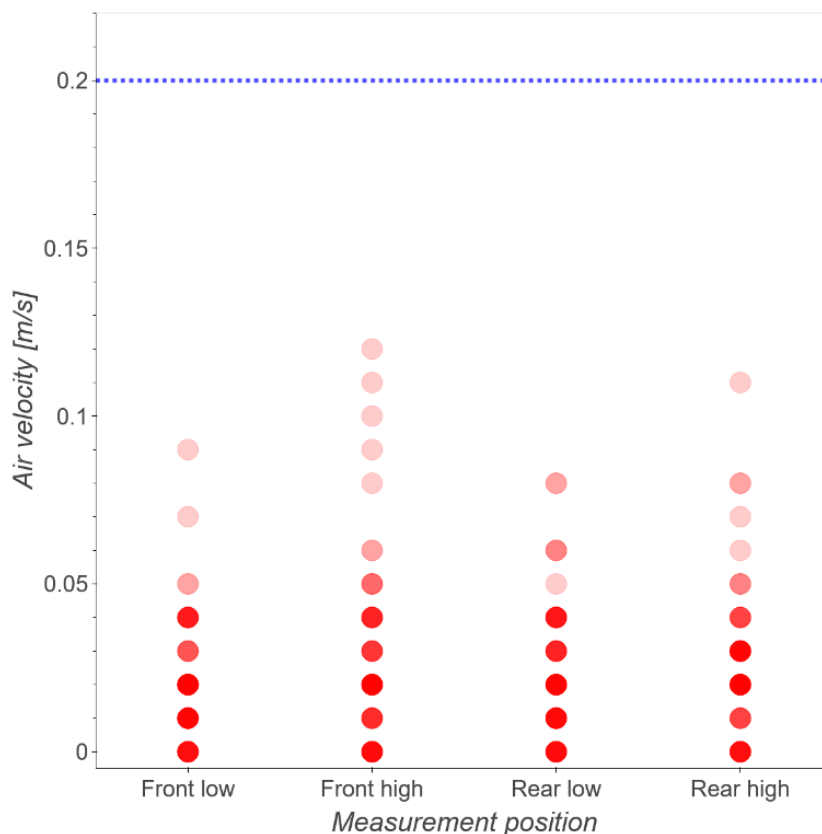
Figure 6: Air velocities in sample vicinity during the first experiment stage. The darker a spot is, the more measurements with the corresponding values were recorded.

The air velocities were measured at the four measurement points described in the test standard (in front of and behind the sample in heights of 100 mm and 600 mm above the sample floor). The measurements were conducted for the test setup of the heat output test of stage 1. The results are shown in Figure 6. None of EGOLF laboratories seems to have a problem achieving the requirement of air velocities at these points that must not exceed 0.2 m/s.

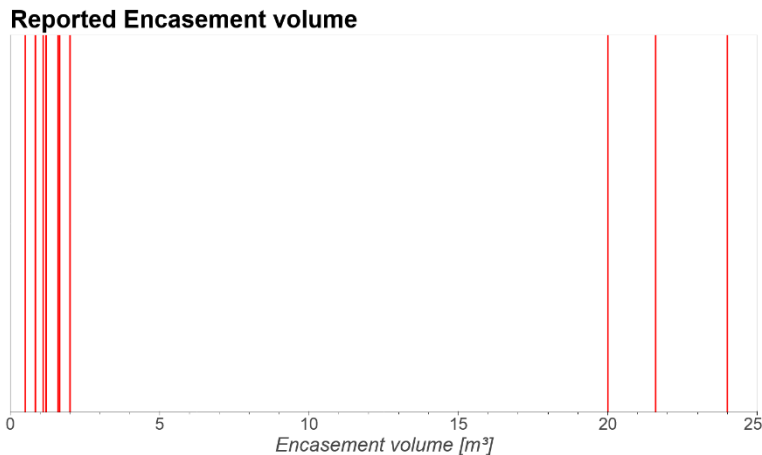
Figure 7: Those laboratories that reported their test rig as "encased" estimated these encasement volumes.

The test rig might or might not be encased in a closed housing that might or might not prevent sufficient oxygen influx for the propane flame. The test standard does not mention any details about this factor. The laboratories were therefore questioned whether their test rig was at all encased in an own housing, and if yes, what the volume of this housing was. Those laboratories that viewed their test equipment as "encased" reported the encasement volumes given in Figure 7. As shown, there are also reported encasement volumes of 20 m³ and above. These volumes are in the range of large rooms or halls and would not have to be counted as encasement that might hinder gas flow. Therefore, these encasements with high volumes were not counted as encasements.

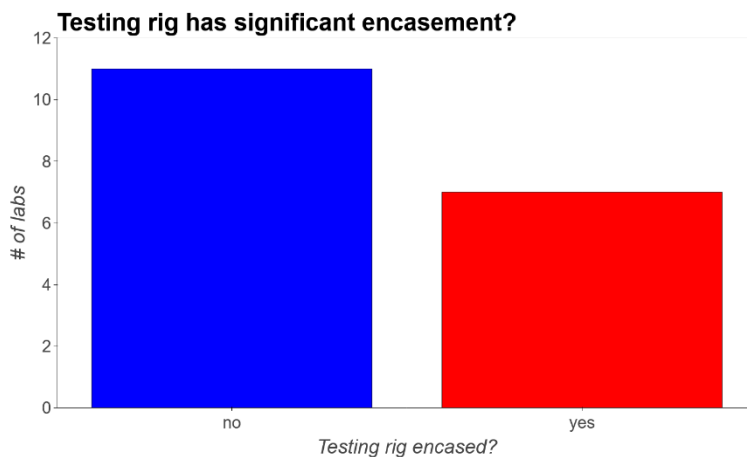
Figure 8: Number of laboratories having encased or not-encased testing equipment.

The number of laboratories that have significant encasements around their test equipment is shown in Figure 8 in comparison with the number of laboratories that have no real encasement but have their test rigs open in large halls or rooms.

There are obviously discrepancies on the surrounding of the sample during the test. About a third had air volumes of up to 2 m³ around their test rig. One laboratory even had only 0.5 m³ available to house the test rig. Said laboratory however could not find any significant differences in the developed temperatures in the heat output test (stage 1) nor in the proficiency tests (stage 2). So therefore, the available volumes are still large enough that no significant influence on test results had to be assumed.

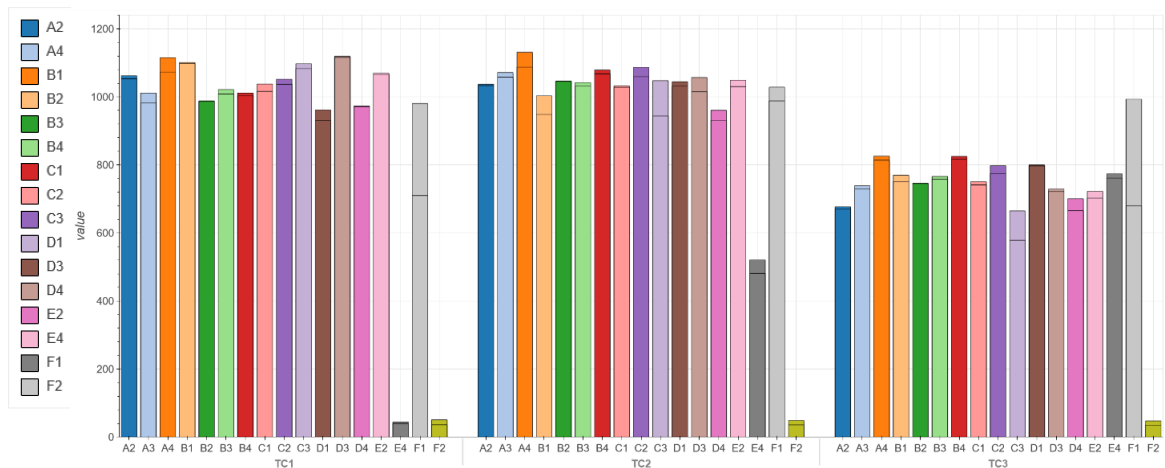
Figure 9: Average equilibrium temperatures during heat output tests in height of the burner (TC1) as well as 2 cm (TC2) and 4 cm above the burner axis (TC3). Two measurements were performed by each lab, depicted by the total length of the bars and a further line near the top of each bar.

The average equilibrium temperatures were calculated in a time window from 40 s to 80 s after the beginning of the test for each of the three measurement positions: TC1 in the height of the burner, TC2 20 mm and TC3 40 mm above the burner axis. In this time frame, all thermocouples had reached an equilibrium temperature that was sufficiently

constant. As this test was conducted twice by each laboratory, the bars in Figure 9 show two distinct values as results.

It can be seen that most laboratories achieve very similar equilibrium temperatures in these time frames, and can also reproduce this in a second test.

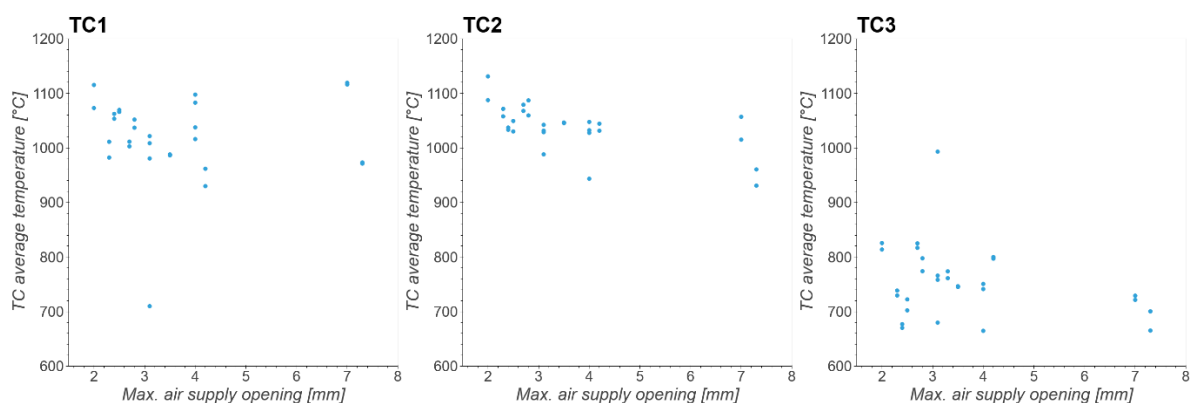
Figure 10: Plots showing the maximum air supply opening of each laboratory over the measured average equilibrium temperatures in all heat output tests. The stray outliers were removed.

As shown in Figure 10, a correlation is hard to find, but if forced, it would not be a positive correlation, but a negative one, meaning that smaller air suppliers correlate with a higher temperature.

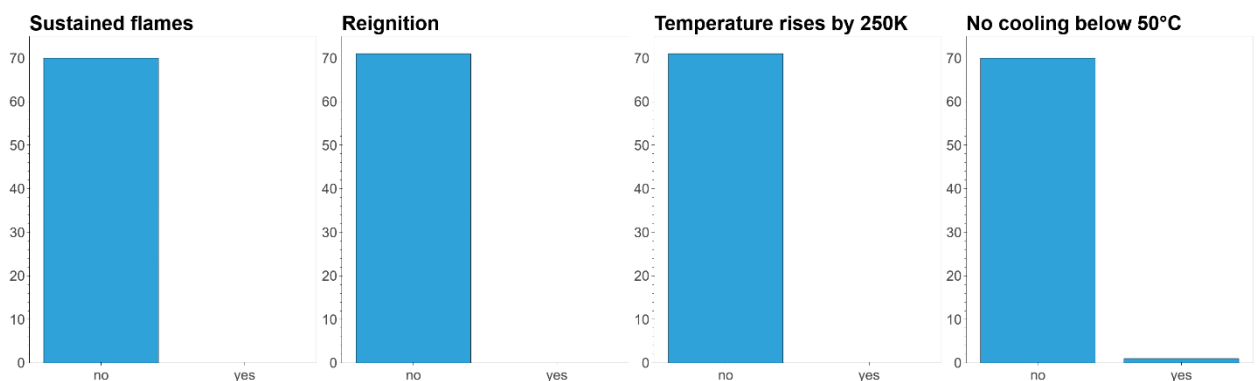
Figure 11: Compilation of the number of all reported observations of the evaluation parameters for continuous smouldering for both materials combined.

Each of the laboratories reported their observations for these four evaluation parameters. The cumulated reports for each effect can be found in Figure 11.

The total number of observations should be 72 (i.e. four observations from each of the 18 laboratories). As some of the observations had to be removed from the evaluation due to several mistakes, the total number is slightly lower.

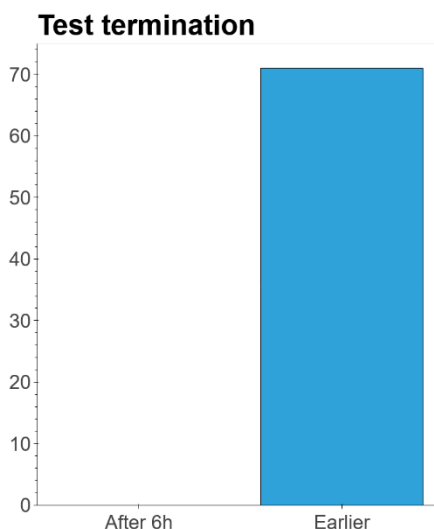
Figure 12: All performed tests were ended early because all smouldering activity in the samples had prematurely ceased.

Figure 12 shows that none of the laboratories had to perform a test for the full duration of 6 hours, because in all tests, all activity in the samples had ceased much earlier. This was discerned by proxy of the internal temperature in a test sample being cooler than 50 °C for more than an hour.

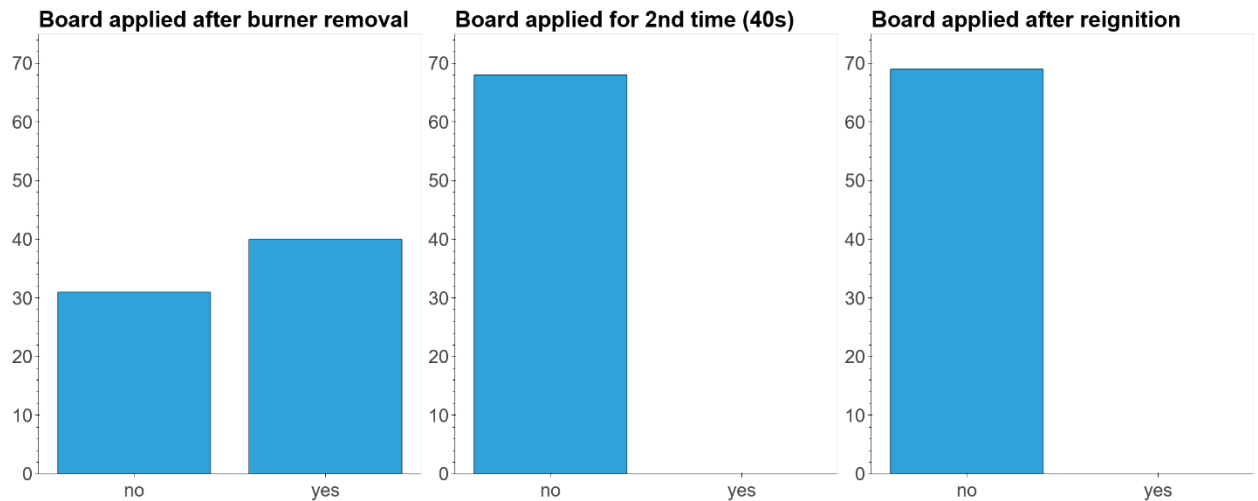
Figure 13: This figure show whether the laboratories applied the extinguishing board to the sample surface according to the provisions of section 8.6.2 from the test standard.

Figure 13 shows that not all laboratories are aware of this detail. EGOLF should therefore propose to CEN that the test standard shall more clearly state that the first application of the extinguishing board is mandatory, or clarify this matter otherwise.
